Solution for the Mercedes 40pin Plug Compatibility with the AUX

Connector

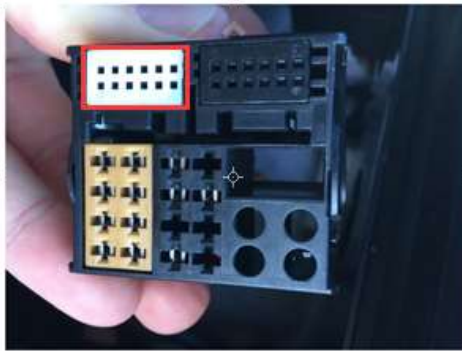
Pic 1

Picture 1 – The original car interface

The original car amplifier will have no sound if you directly plug the connector marked red.

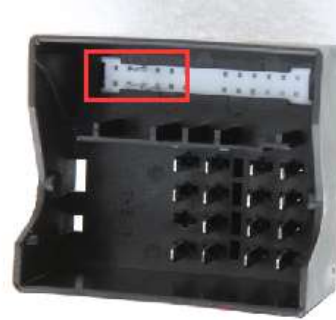
Pic 2

Picture 2 – The aftermarket unit's ISO wiring interface
